Quay Marine Associates Inc.

Condition Survey

MV "CARUSO"

MV "CARUSO"
Condition Survey
At Dartmouth, Nova Scotia
18th March 2003

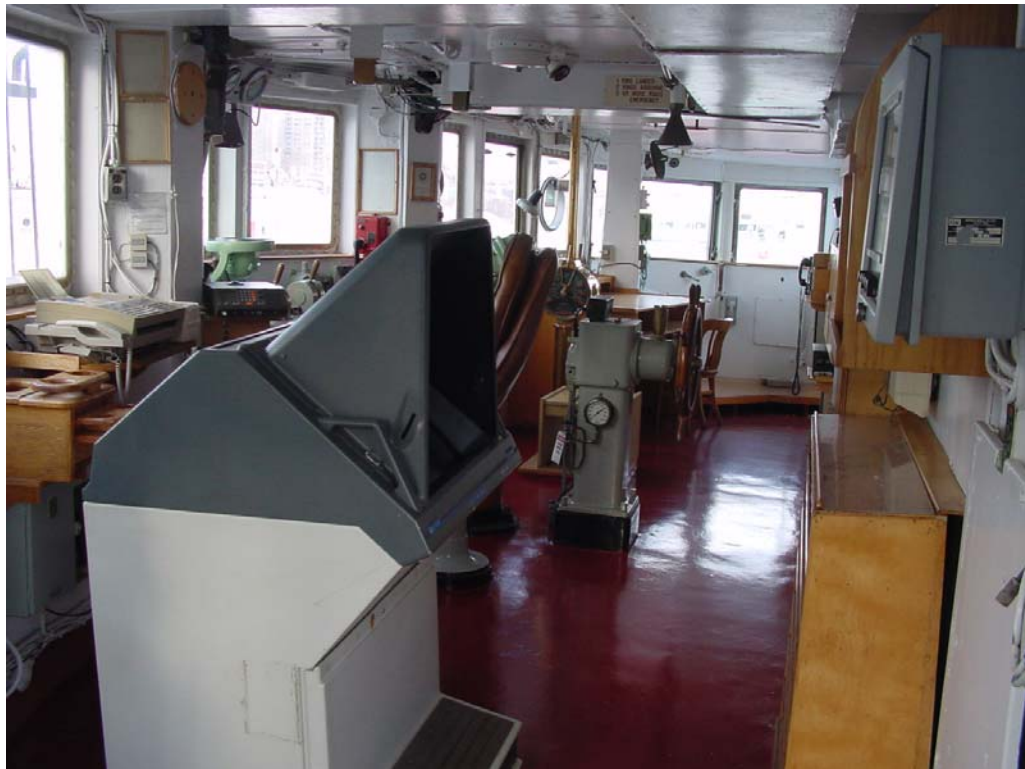
The wheelhouse was found to be dry and clean, some electronic equipment has been removed as evidenced by terminated wiring. The bridge windows were found intact and the sliding windows operational.

Photograph 1: General view looking to port across the wheelhouse.

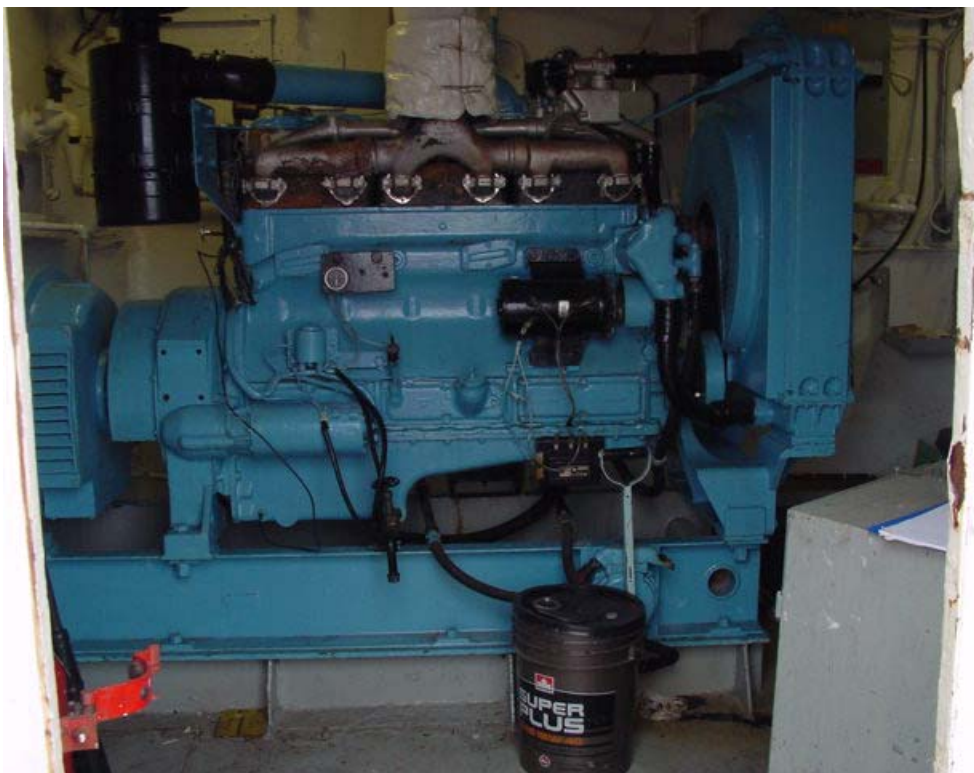
Aft of the radio room in a separate compartment accessible from the deck is the Emergency Generator Room containing the emergency switchboard the emergency generator and the emergency generator fuel tank. The space was clean, well lit and heated. The emergency generator is fully operational and has been tested under load a number of times in the past three months.

Photograph 2: General view looking at the Emergency Generator.

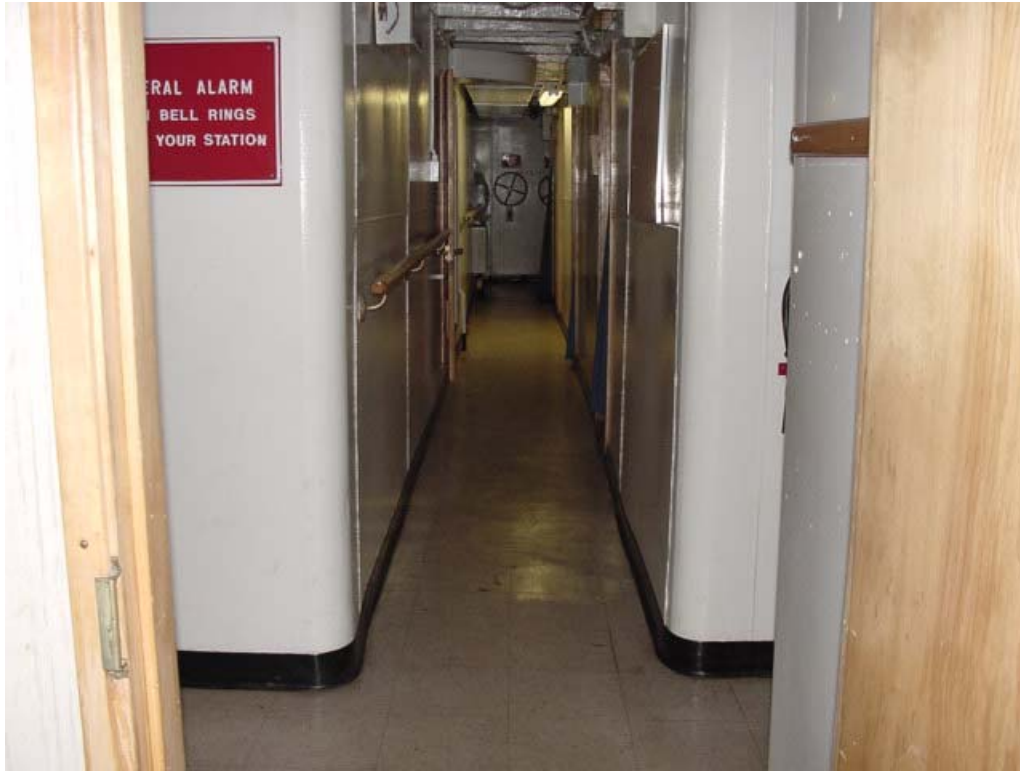
The accommodations were found to be dry and odour free.

Photograph 3: General view looking aft from the Officer's Dining Room.

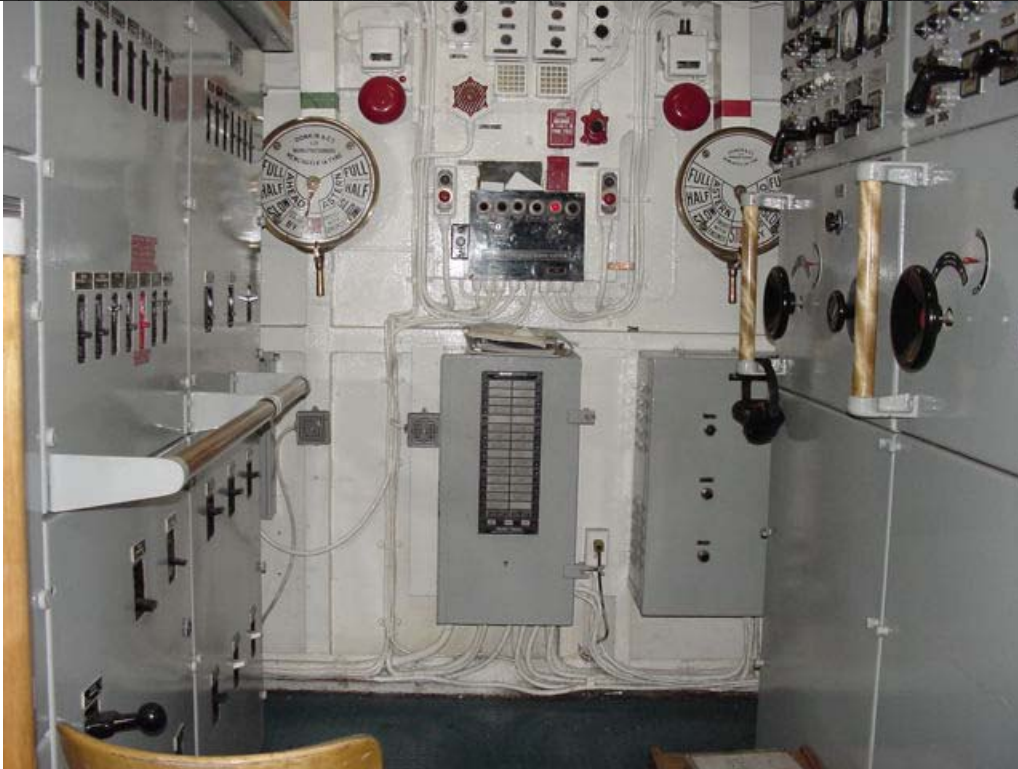
The space was found to be clean and well lit, the switch boards were found intact, the forward and aft facing windows were found in tact, all exposed wiring appeared to be in good condition.

Photograph 4: View looking aft in the Control Room between the switch boards.

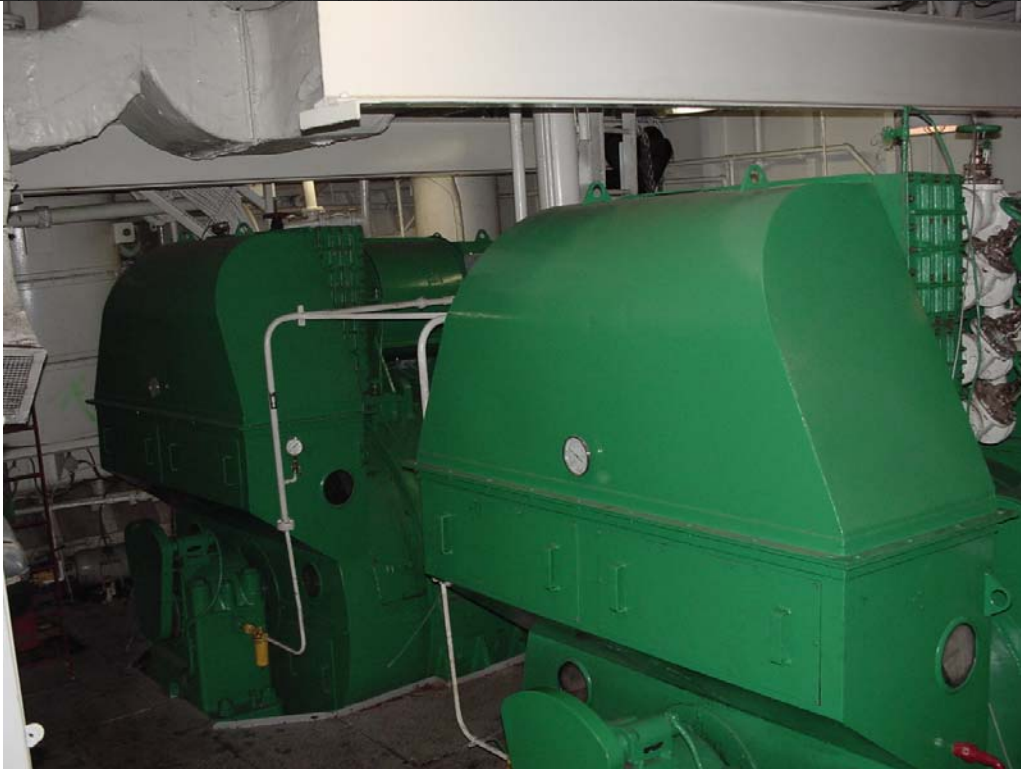
It was noted that there was a small amount of water in the propulsion motor bilges but no signs of leakage at any of the pipe work.

Photograph 5: General view looking aft to starboard in the Propulsion Motor Room.
